*U.S. Department of Energy
Office of Legacy Management*

2006 Annual Site Inspection and Monitoring Report for Uranium Mill Tailings Radiation Control Act Title I Disposal Sites

December 2006

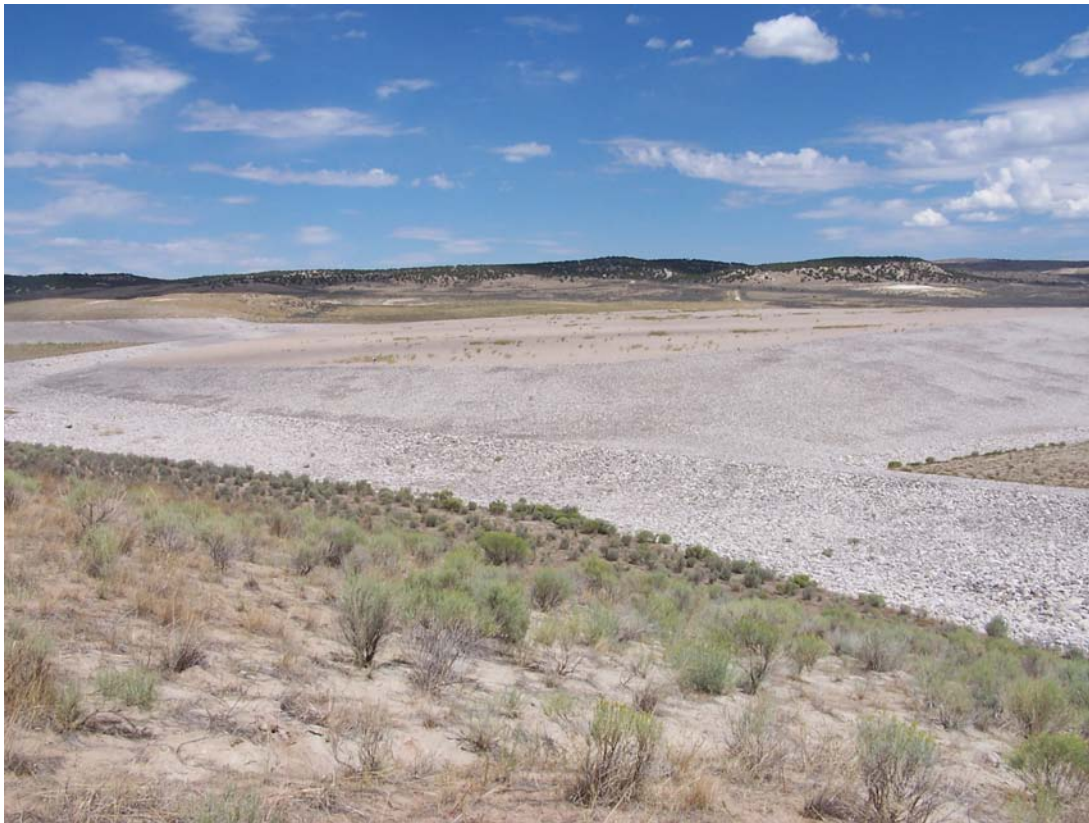
Disposal Cell—The disposal cell is armored with rock for erosion protection and was in excellent condition (PL-3). No evidence of slumping, settling, erosion, or rock degradation was noted.

MAY 8/2006. PL-3. North view of the disposal cell.

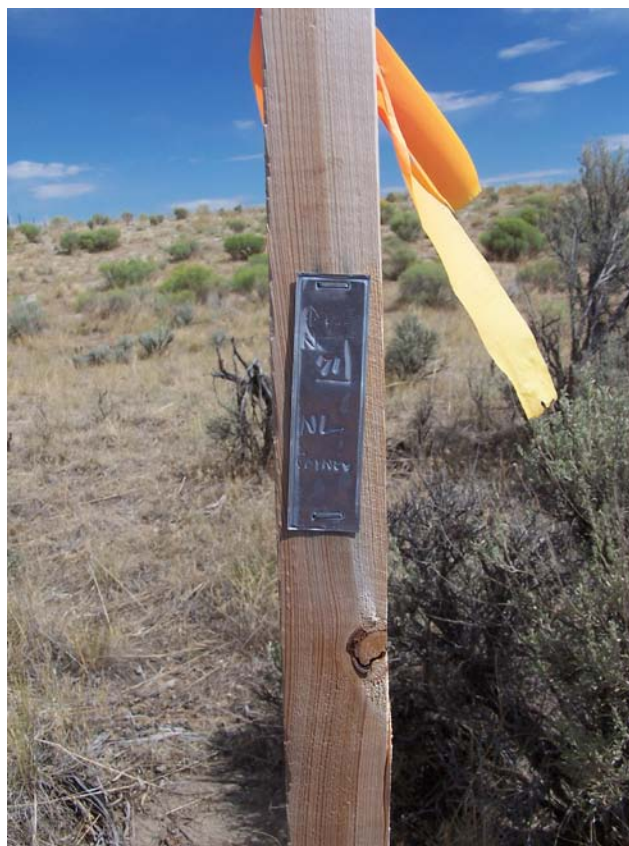
MAY 8/2006. PL-4. Information plate on a new survey stake located inside the west property boundary.

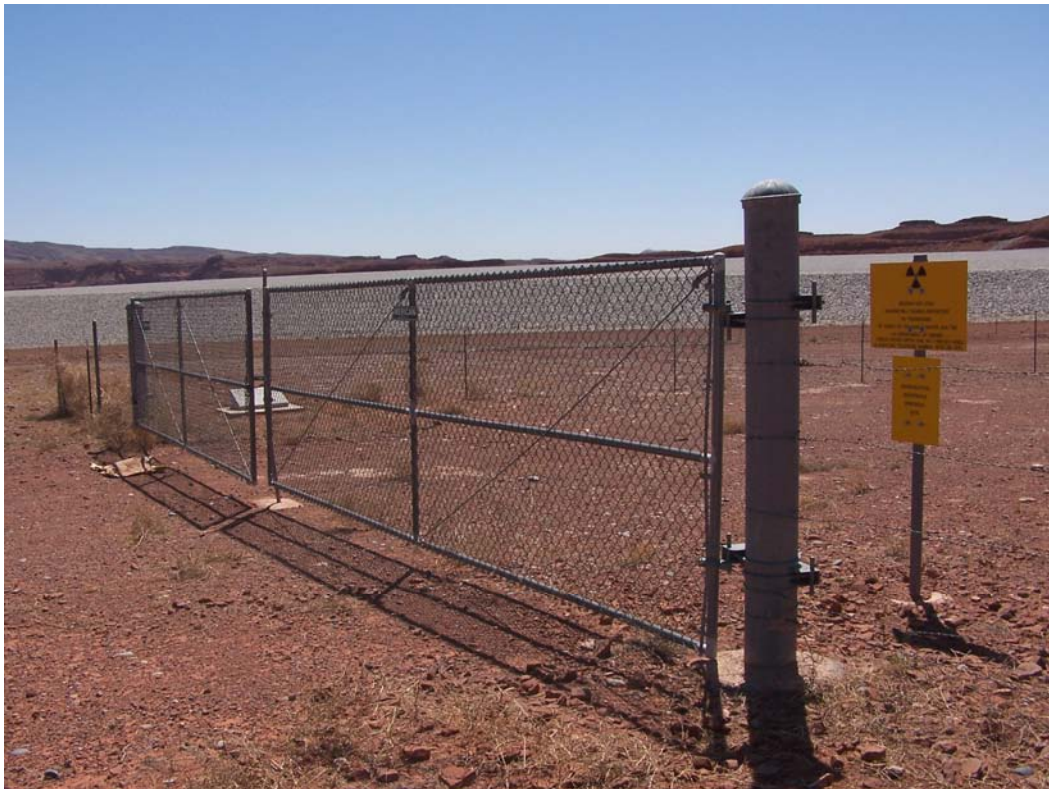
HAT 4/2006. PL-1. Entrance gate (showing bent center rod) and sign, site marker; disposal cell in the background.

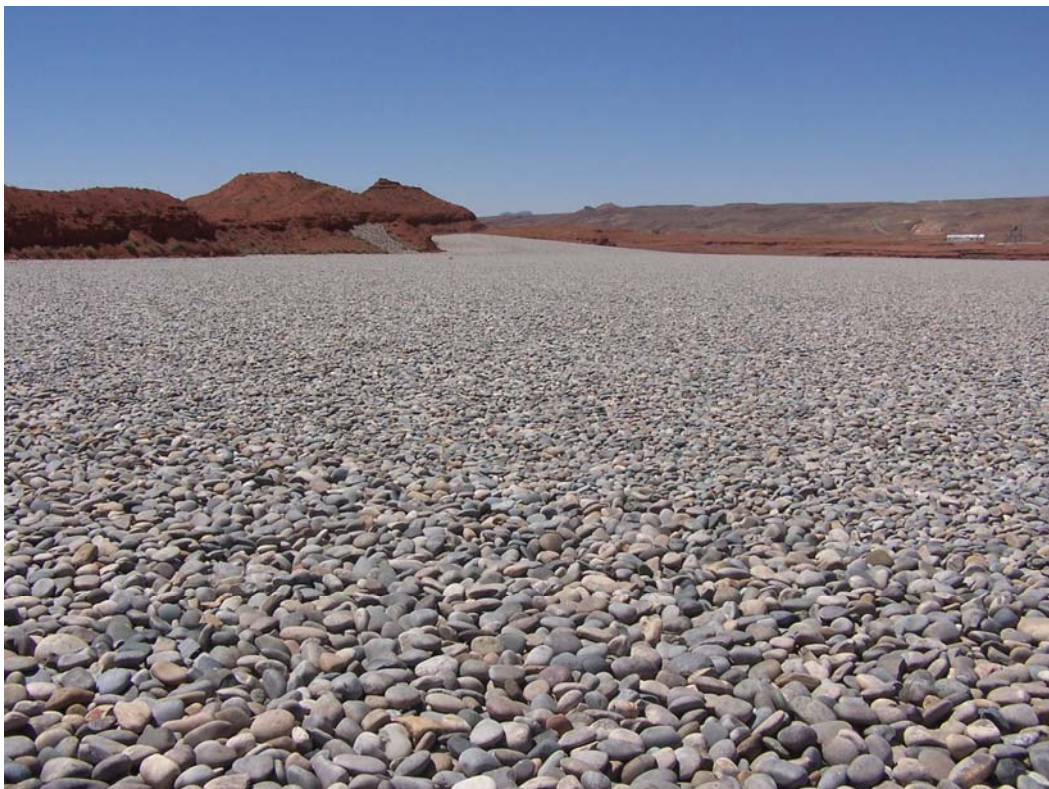
HAT4/2006. PL-2. View southwest across the cell top from the crest of the east side slope of the cell; south slope of the cell top in the background.

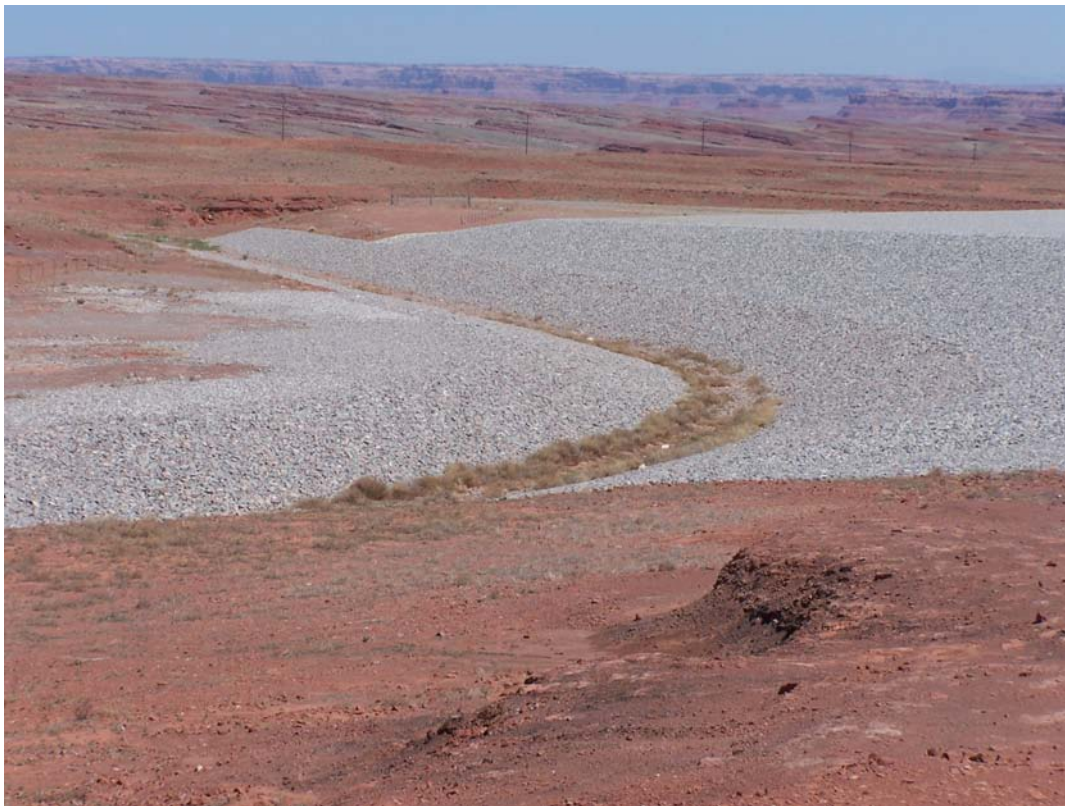
HAT 4/2065. PL-4. Sediment and vegetation in the upper reach of the west diversion channel.

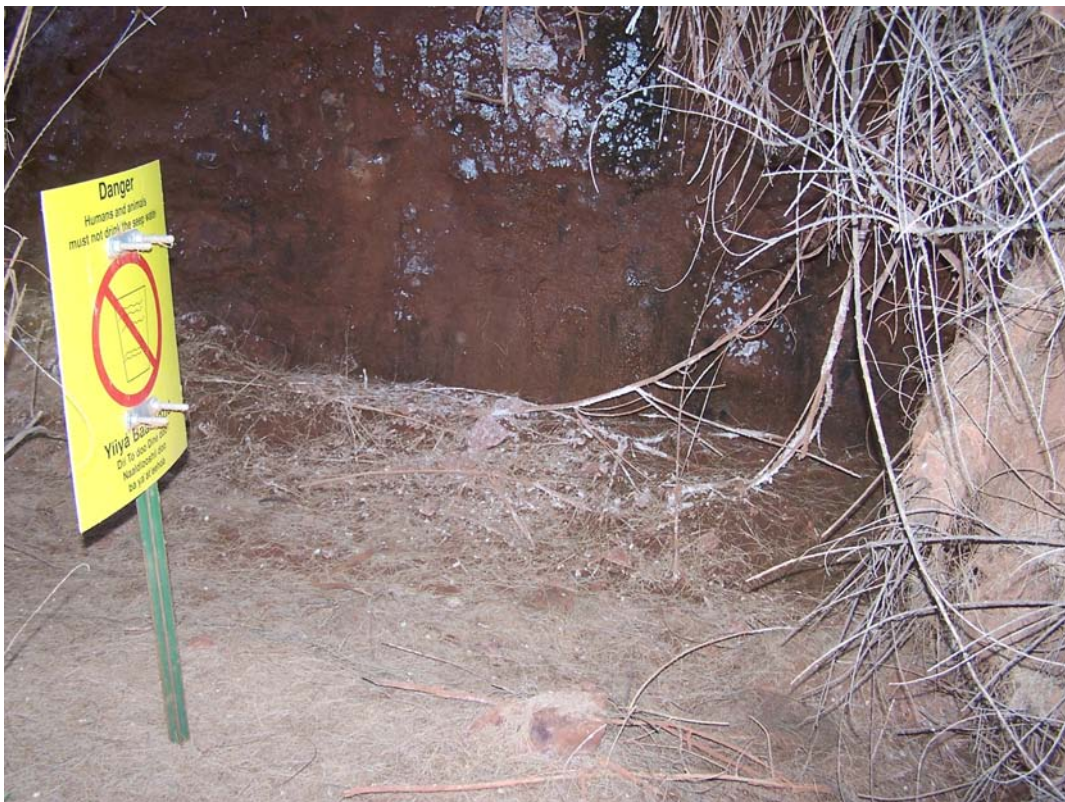
HAT 4/2006. PL-6. Seep 0248.

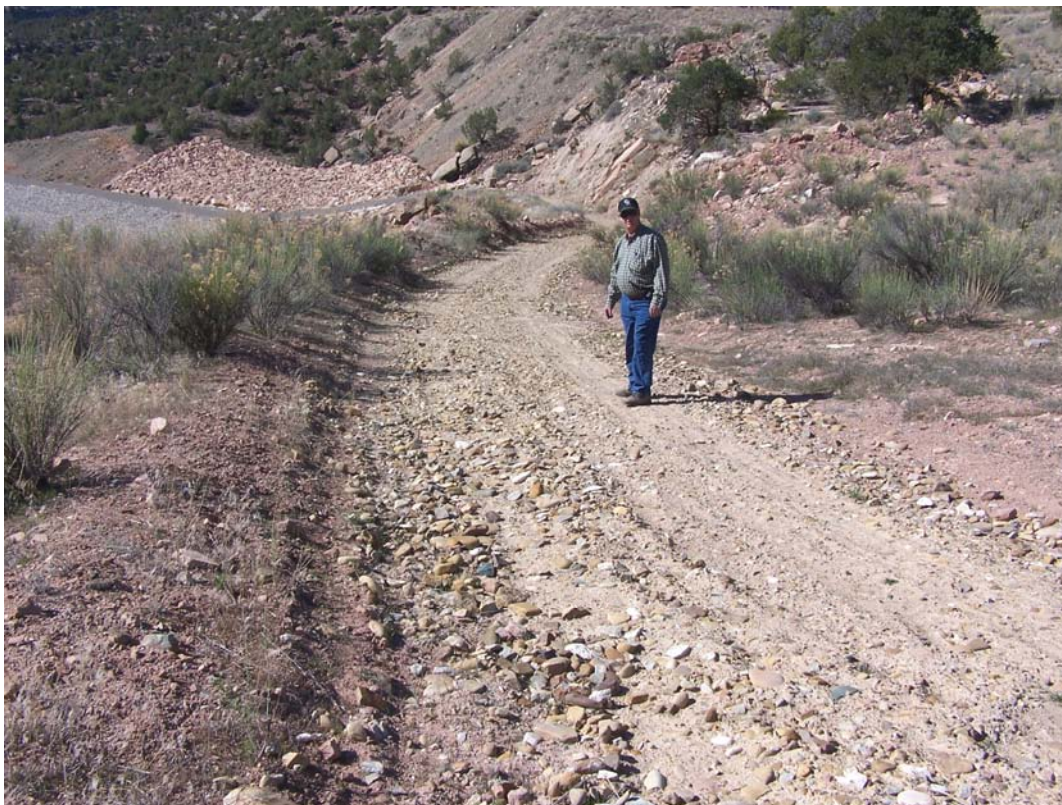
NAD 4/2006. PL-1. Site access road to monitor wells.

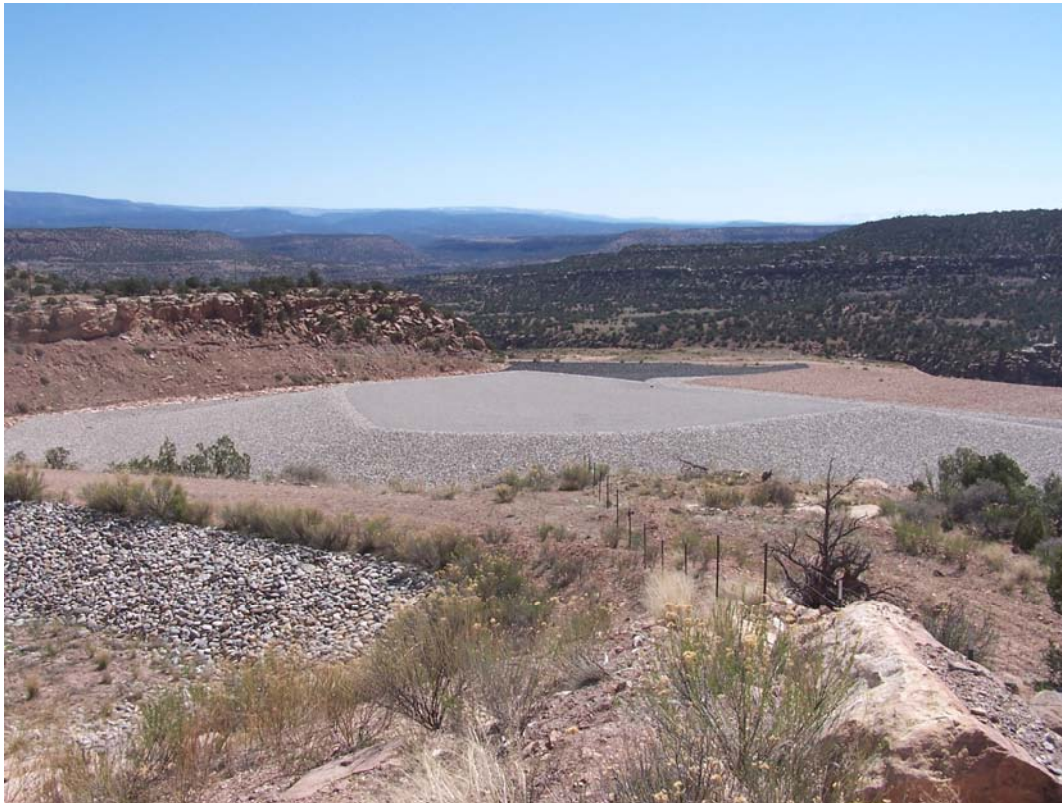
Top of Disposal Cell and Side Slopes—The disposal cell was completed in 1998. Rock covers the 2-acre top of the disposal cell and the approximate 8 acres of side slopes (PL–2). The rock is rounded, with larger rock on the side slopes than on the top. The rock-covered surfaces showed no signs of disturbance except on the southwest side of the top surface. This is an area where a standpipe was removed several years ago and the slightly irregular surface is the result of that activity. The remaining portions of the cell top and side slopes of the disposal cell were in excellent condition. No evidence of subsidence, differential settlement, slumping, or other modifying process was noted, and no vegetation was present.

NAD 4/2006. PL-2. The disposal cell viewed from boundary monument BM-8.

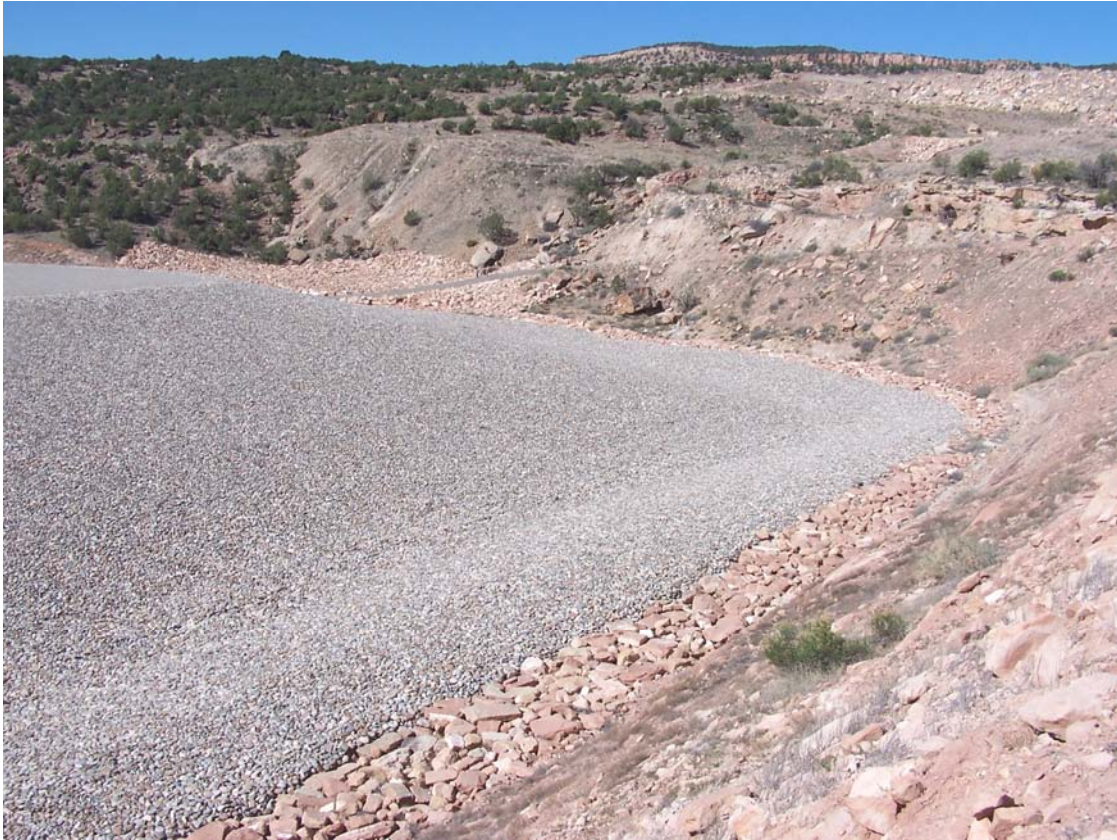
NAD 4/2006. PL-3. The northwest corner of the disposal cell showing the east toe drain.

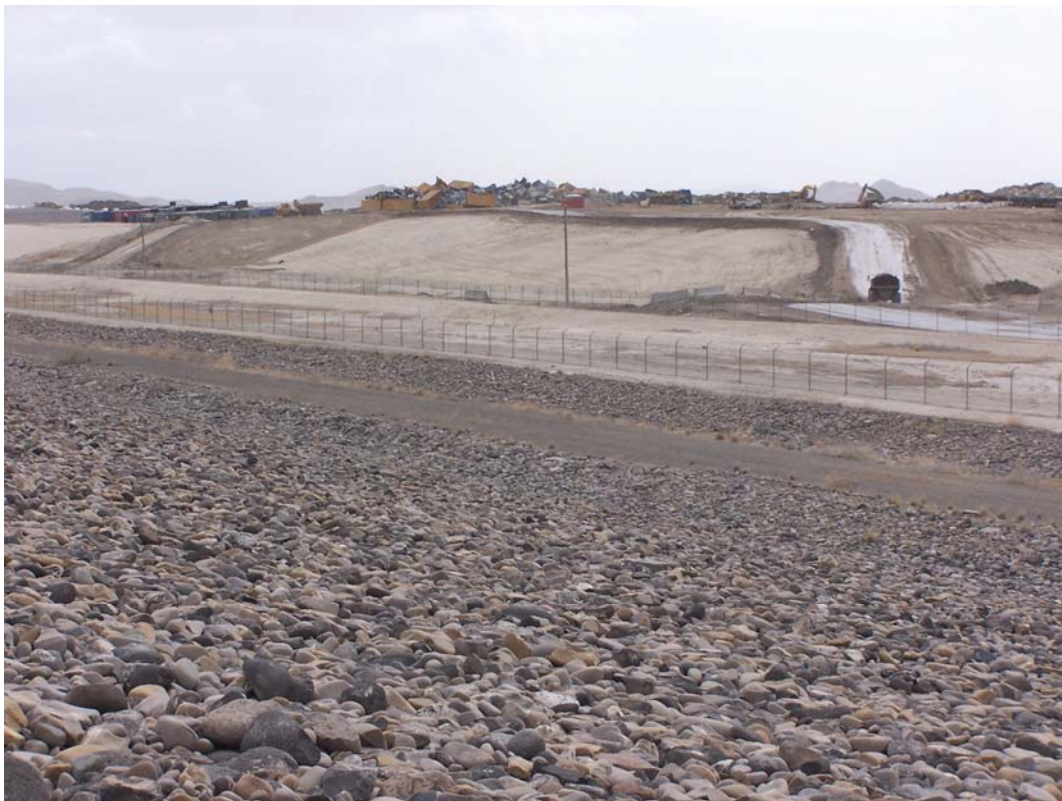
SLC 3/2006. PL-1. Energy Solutions active waste disposal operations directly west of the site.

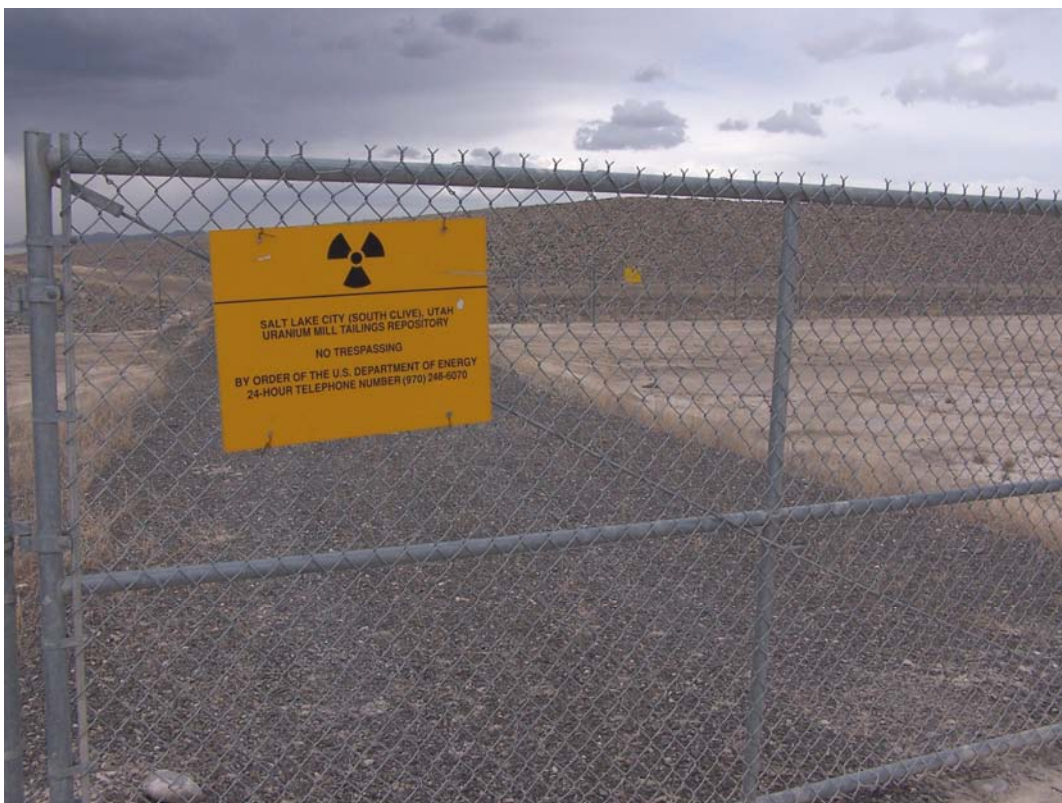
The entrance sign, located on the current entrance gate, was in excellent condition (PL–2). All perimeter signs were present and in good condition.

SLC 3/2006. PL-2. Entrance sign and gate; disposal cell in background.

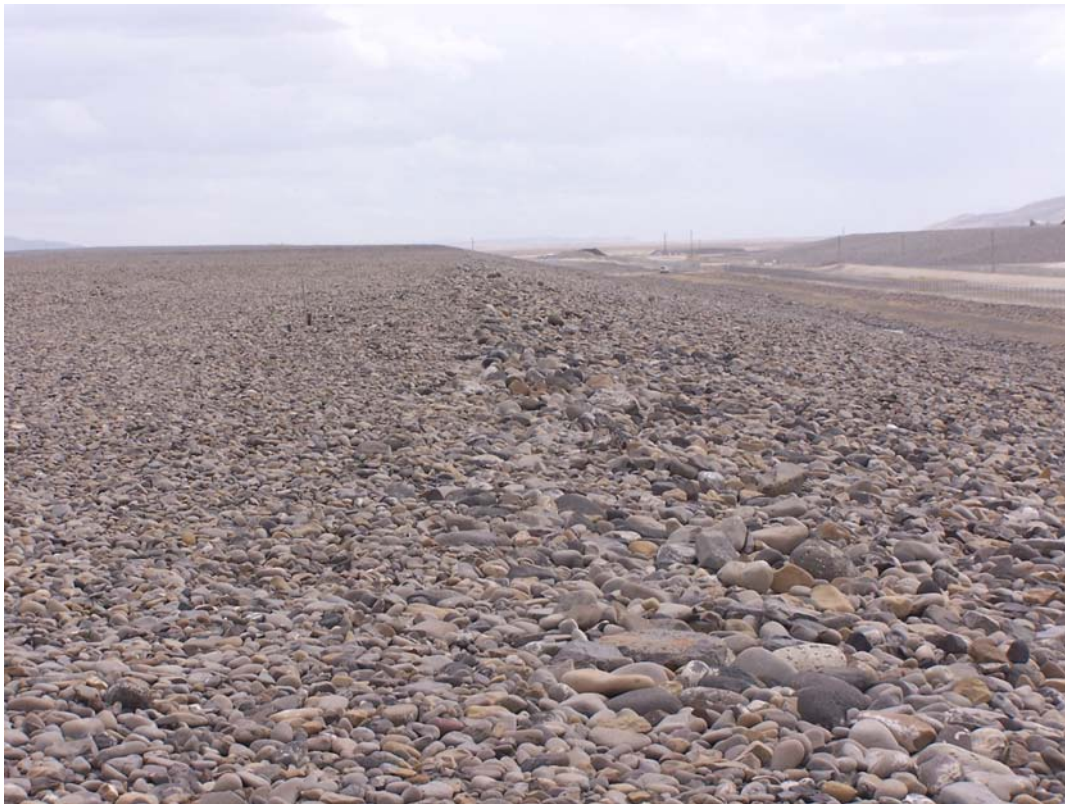
SLC 3/2006. PL-3. Western portion of the disposal cell top showing west side slope of the cell.

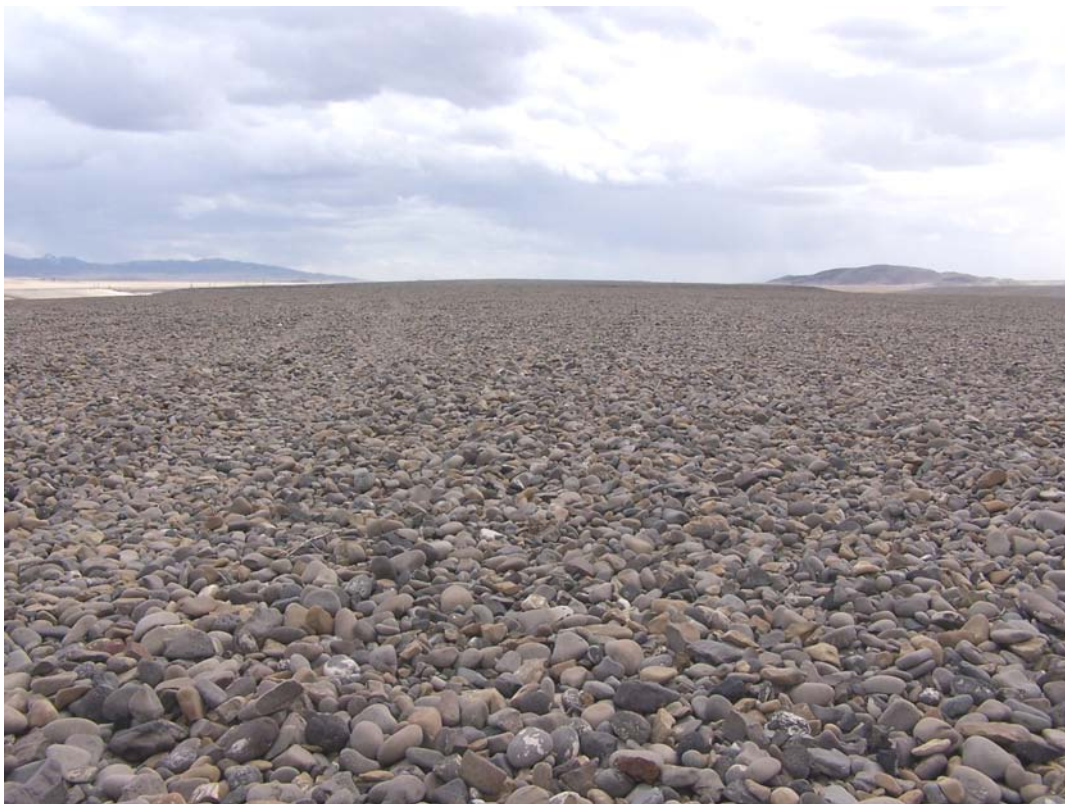
SLC 3/2006. PL-4. View south from SM2 attempting to show slight depressions in center portion of the disposal cell top.

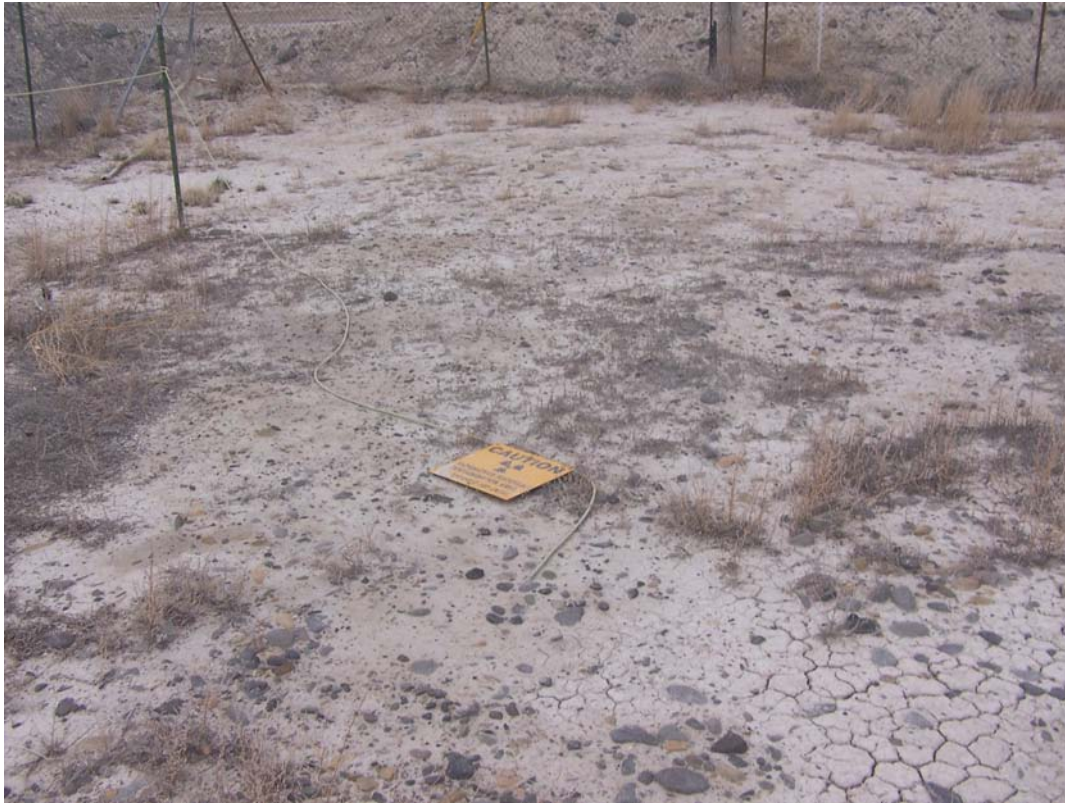
SLC 3/2006. PL-5. Previously excavated radiological contamination area in the southwest corner showing back-fill and fallen radiological barrier rope and posting.

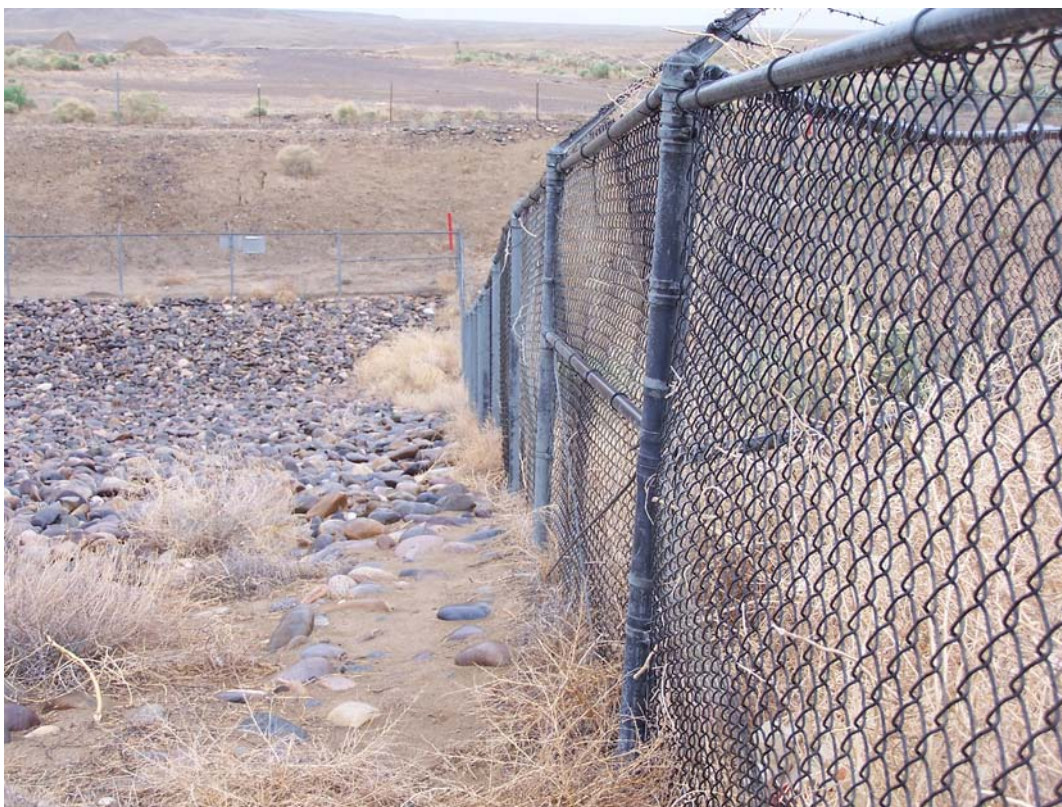
SHP 6/2006. PL-1. Trash and tumbleweeds along southwestern portion of the perimeter fence.

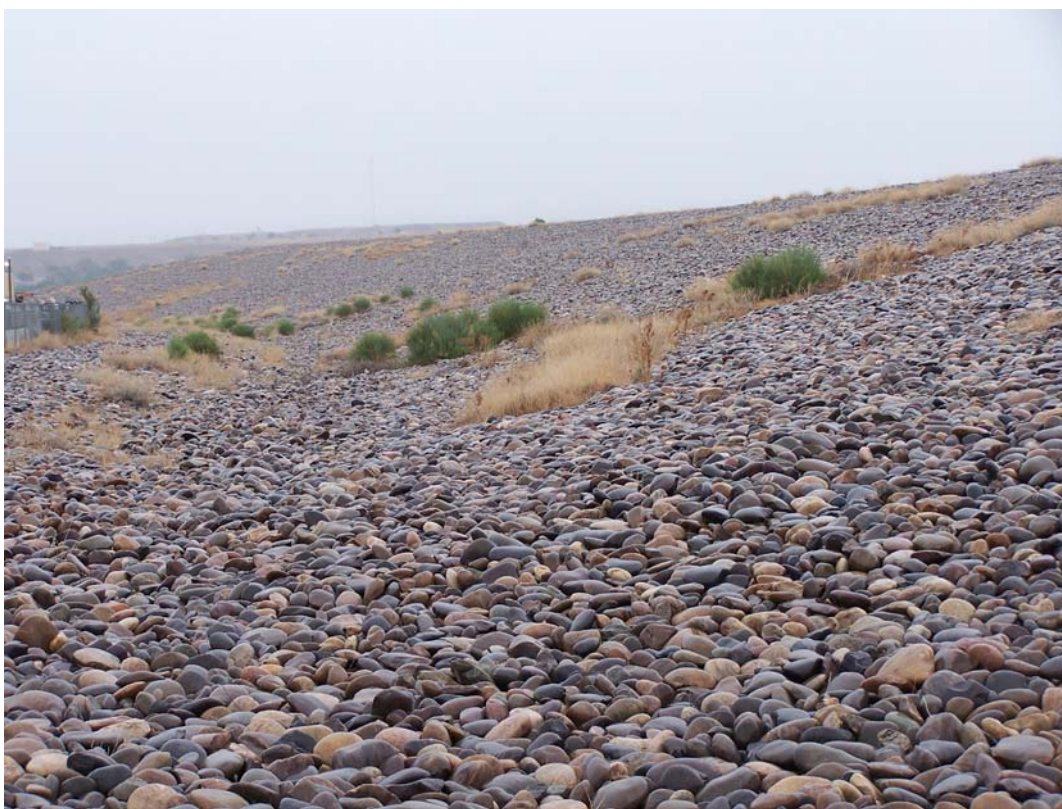
SHP 6/2006. PL-2. Vegetation on west side of cell.

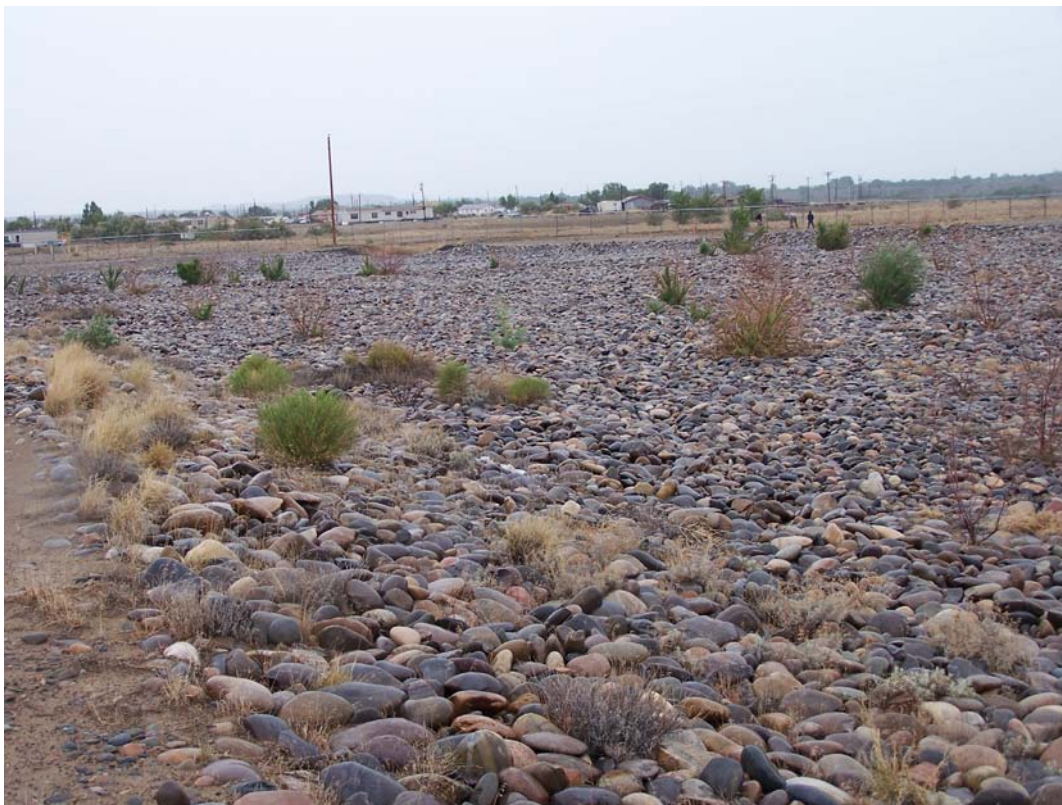
SHP 6/2006. PL-3. Vegetation in outflow area.

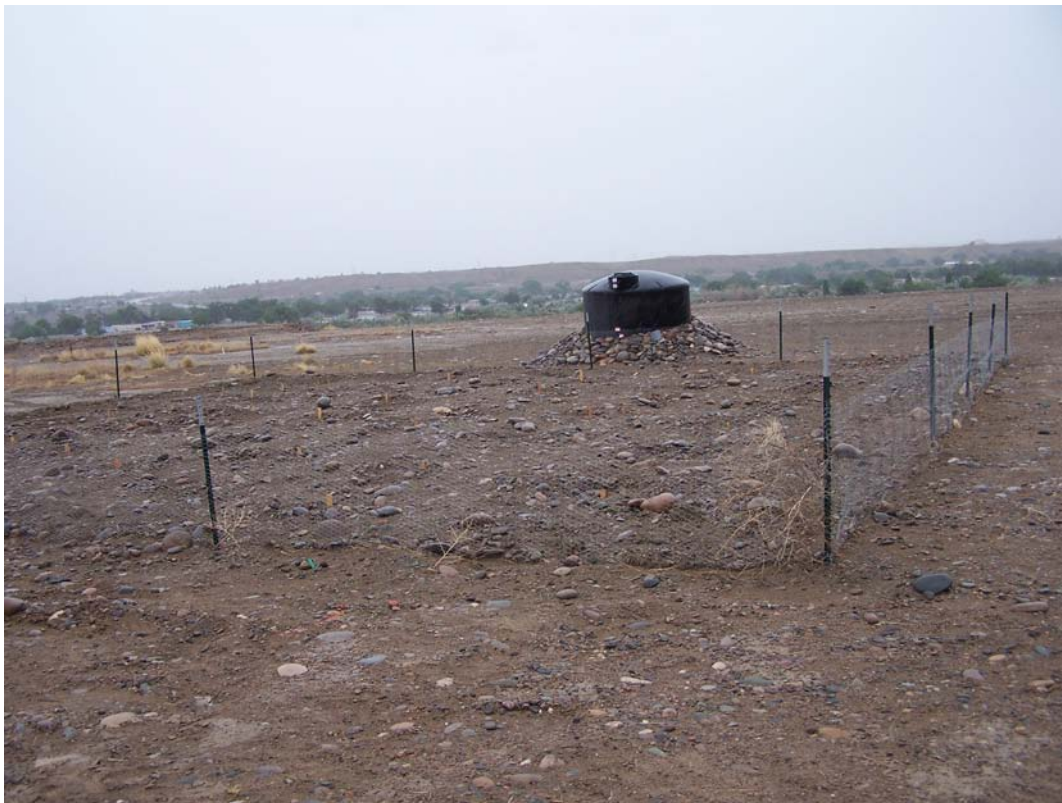
SHP 6/2006. PL-4. Northern phytoremediation test plot.

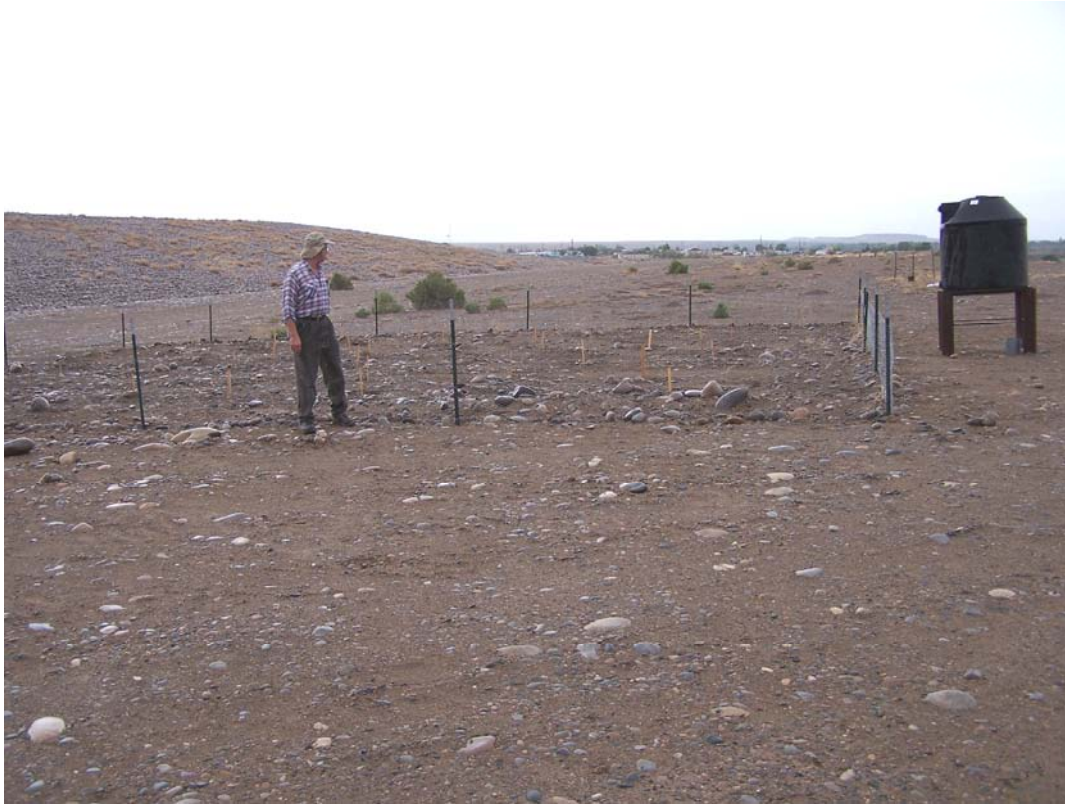
SHP 6/2006. PL-5. Southern phytoremediation test plot.

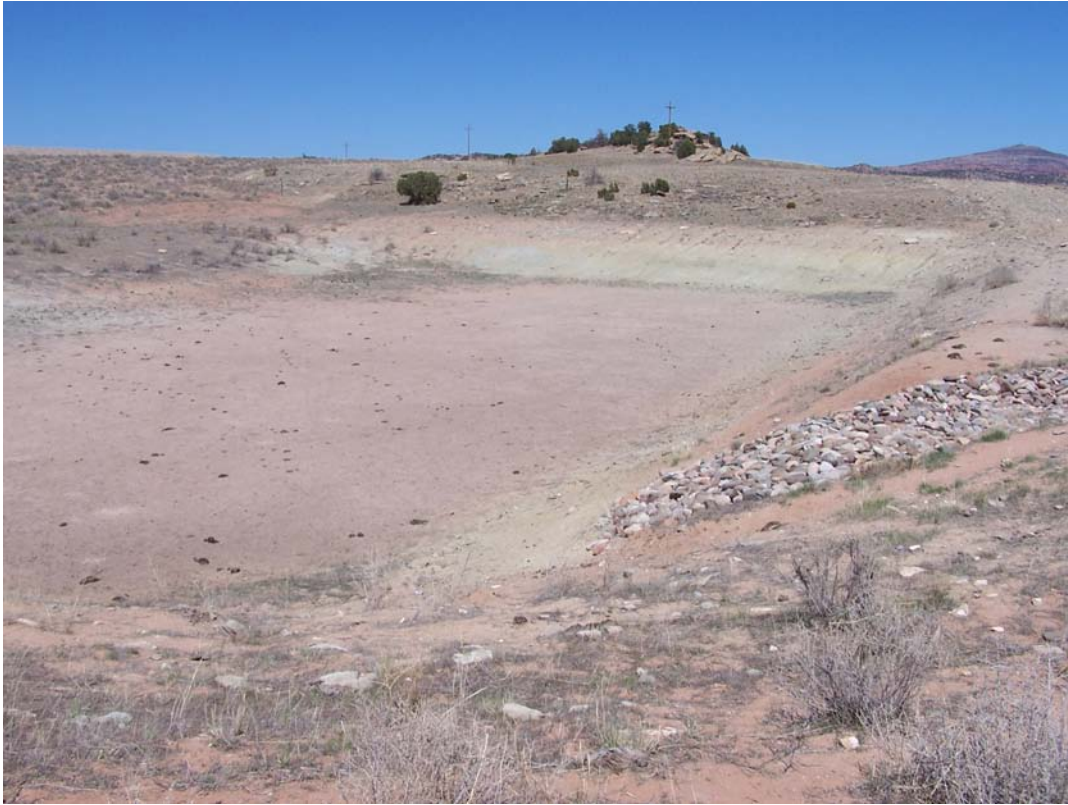
Area Between the Disposal Cell and the Site Boundary—The area around the disposal cell includes the retention pond and the graded and reseeded areas. Surface drainage from the disposal cell flows south into the retention pond, which is constructed in a channel tributary to Joe Davis Canyon. An outflow channel below the pond is lined with rounded cobblestones for a short distance. The pond, which was dry at the time of the inspection (PL–1), and outflow channel were in good condition. Evidence of erosion along the western side of the pond heading toward the access road was noted and will be monitored.

SRK 4/2006. PL-1. Dry retention pond.

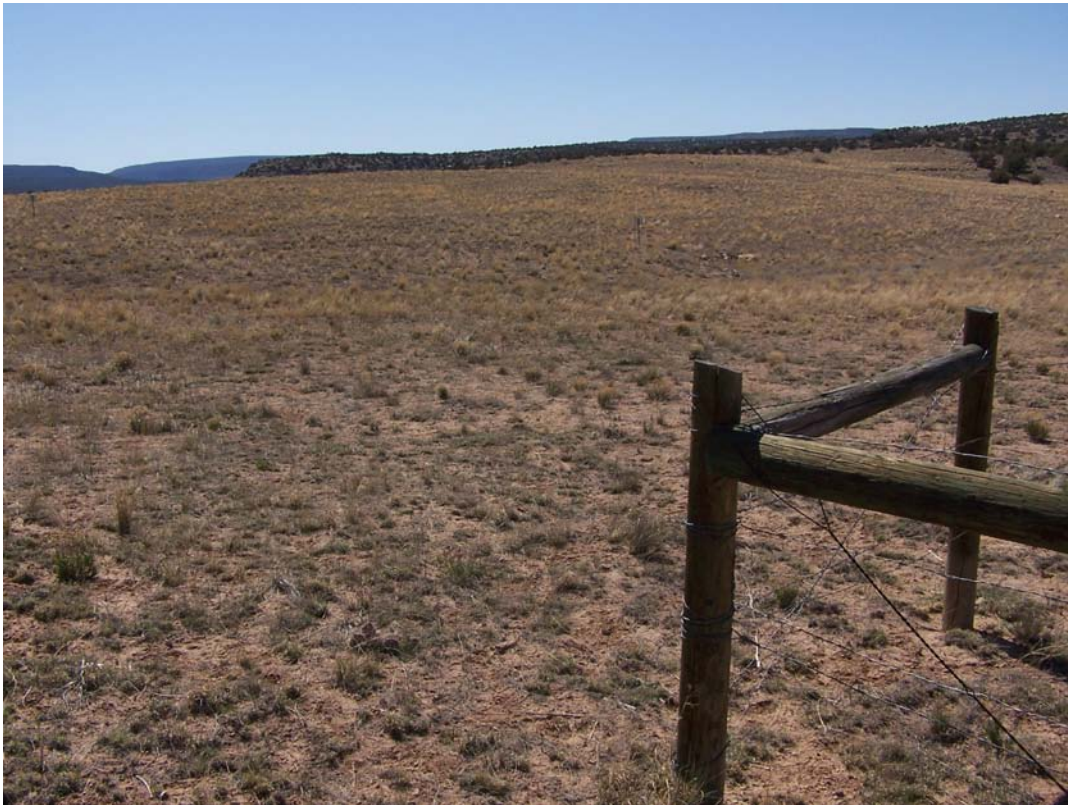
SRK 4/2006. PL-2. Revegetated spoils pile west of the site.

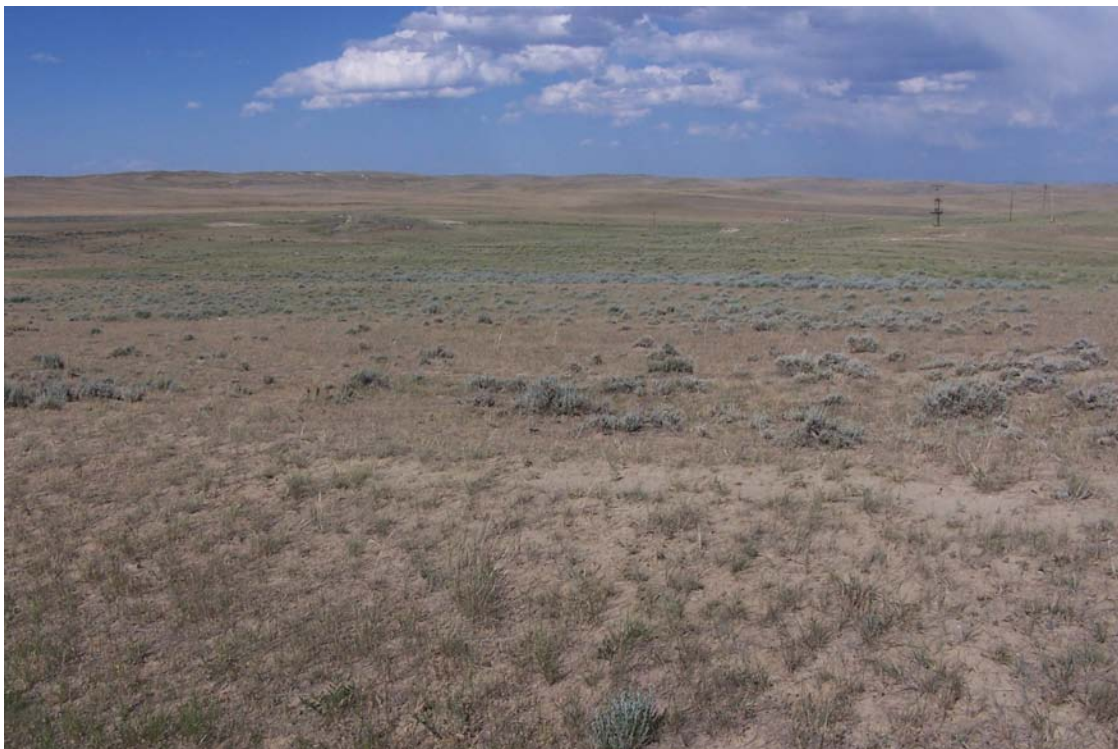
The surface of the site, completed in 1989, was in excellent condition. No evidence of settling was observed over the former mine pit. Vegetation across the site, consisting of grasses and forbs, appears healthy and is indistinguishable from that which grows on the surrounding hills and valleys (PL-3). The same species are present and the overall health and density of vegetation are similar.

SPK 6/2006. PL-3. View northeast across the disposal site from perimeter sign P10.

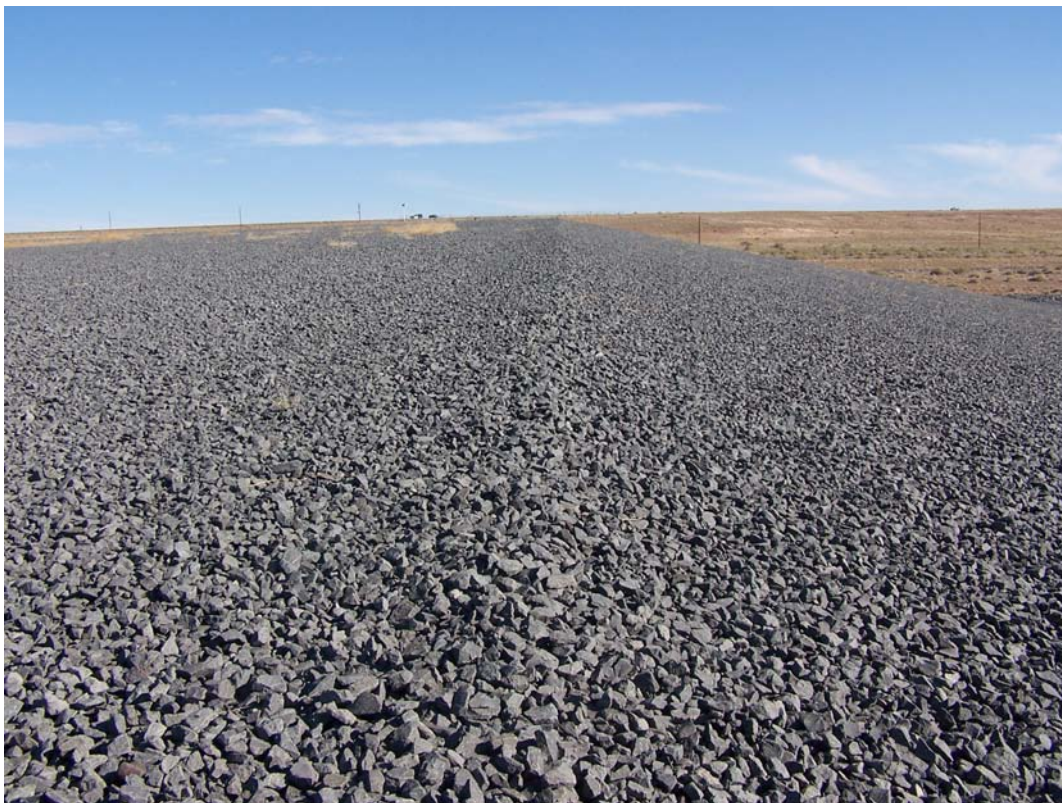
TUB 4/2006. PL-1. View north along the crest of the east side slope.

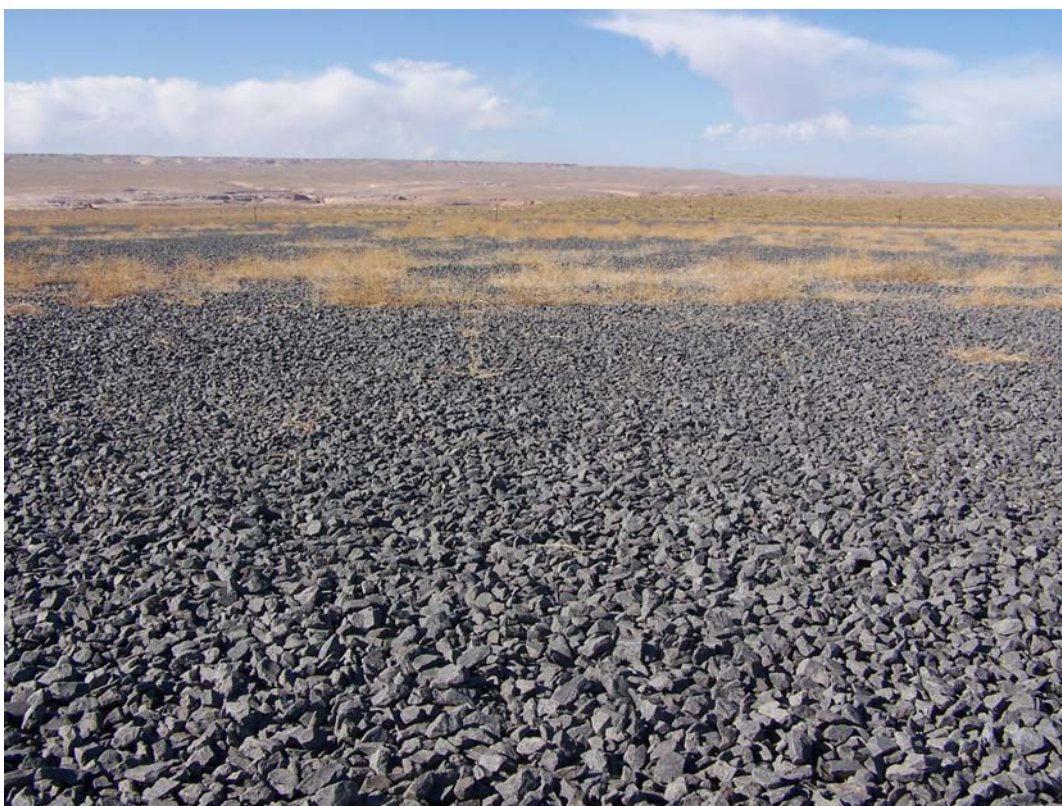
TUB 4/2006. PL-2. Grasses and annual weeds on the disposal cell top.

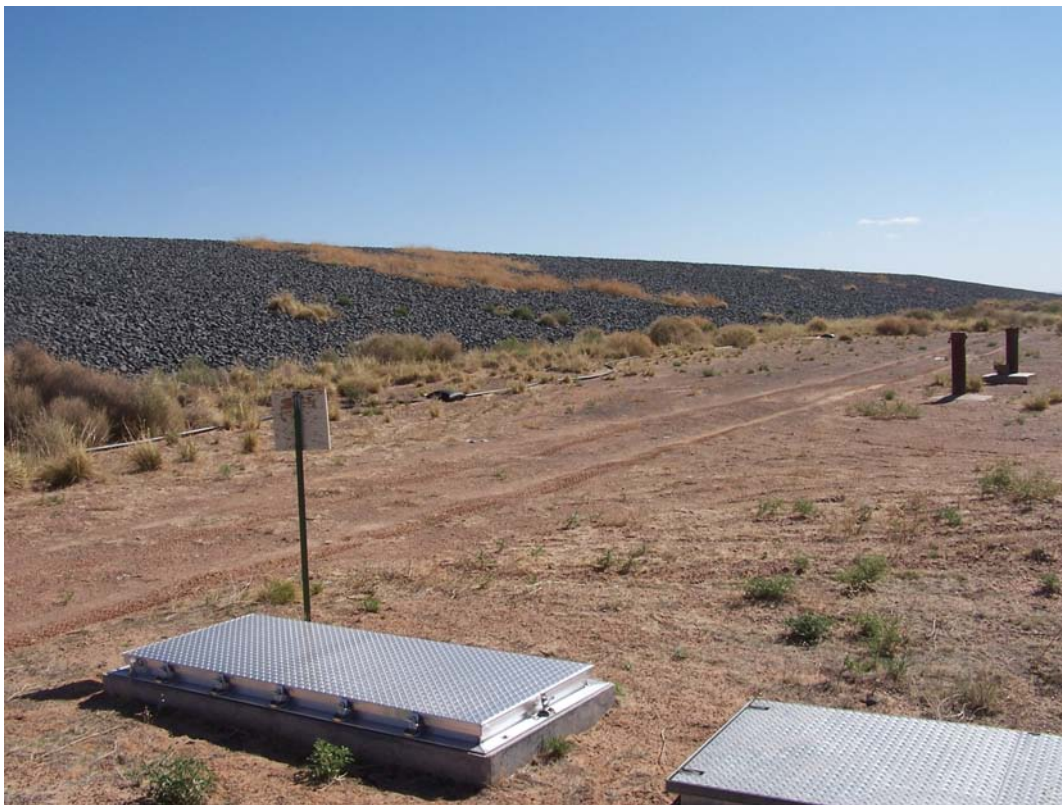
TUB 4/2006. PL-3. Vegetation encroachment on the south side slope of the disposal cell (reference photograph).

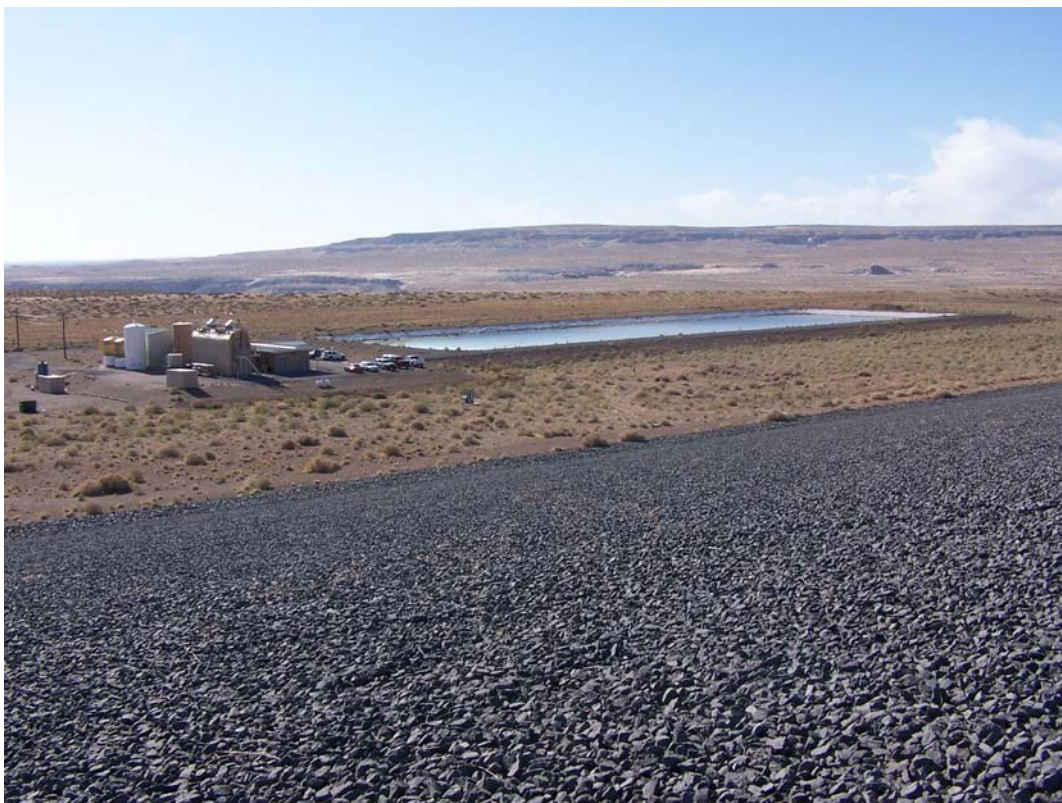
TUB 4/2006. PL-4. Ground water treatment plant and evaporation pond east of the disposal cell.
